INSIDE A SOVIET ICBM SILO COMPLEX: THE SS-18  
SILO DISMANTLEMENT PROGRAM AT DERZHAVINSK,  
KAZAKHSTAN

August 2000

*Technical Report*

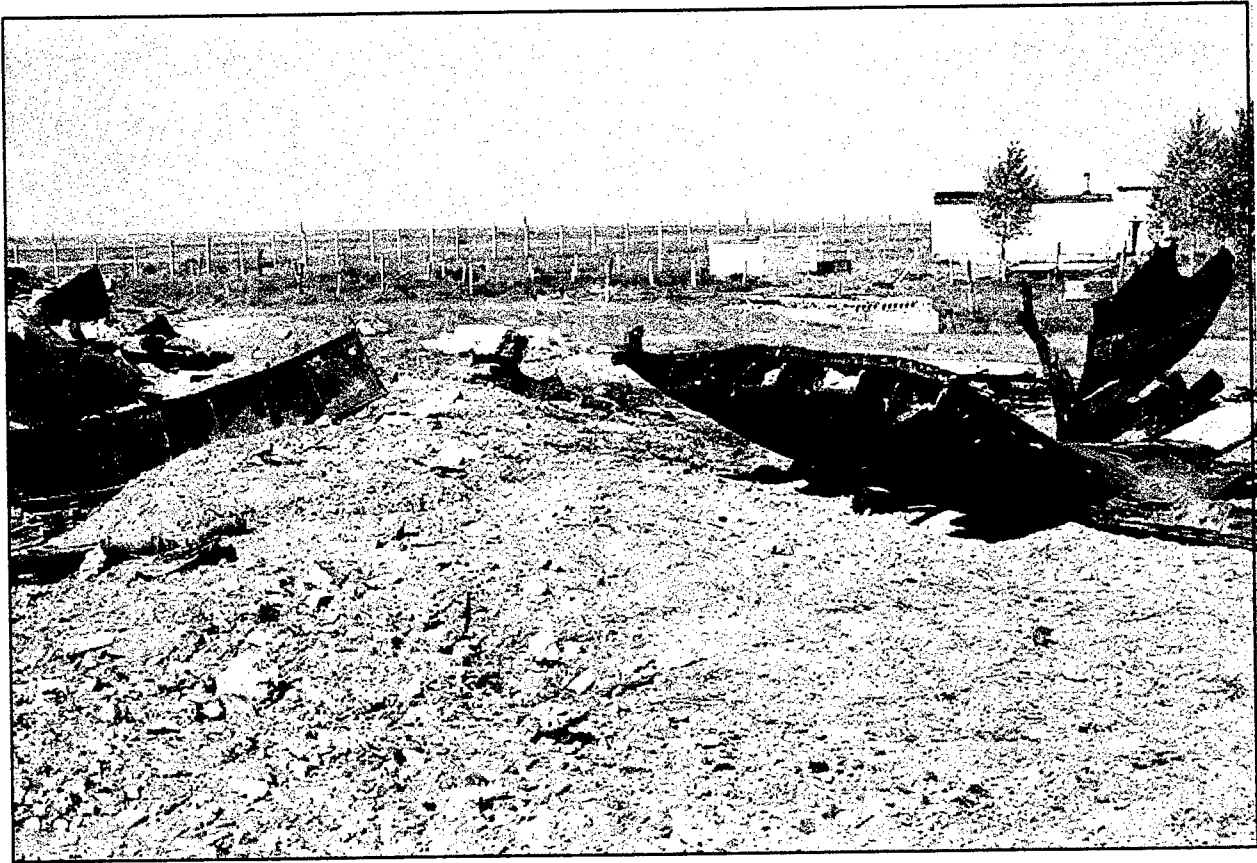
Figure 8. Metal and concrete debris on the crater rim. The ribbed metal plate on the right may be part of the headworks wall. The transformer substation is in the right background. Derzhavinsk, Regiment 2, Silos 5/7.

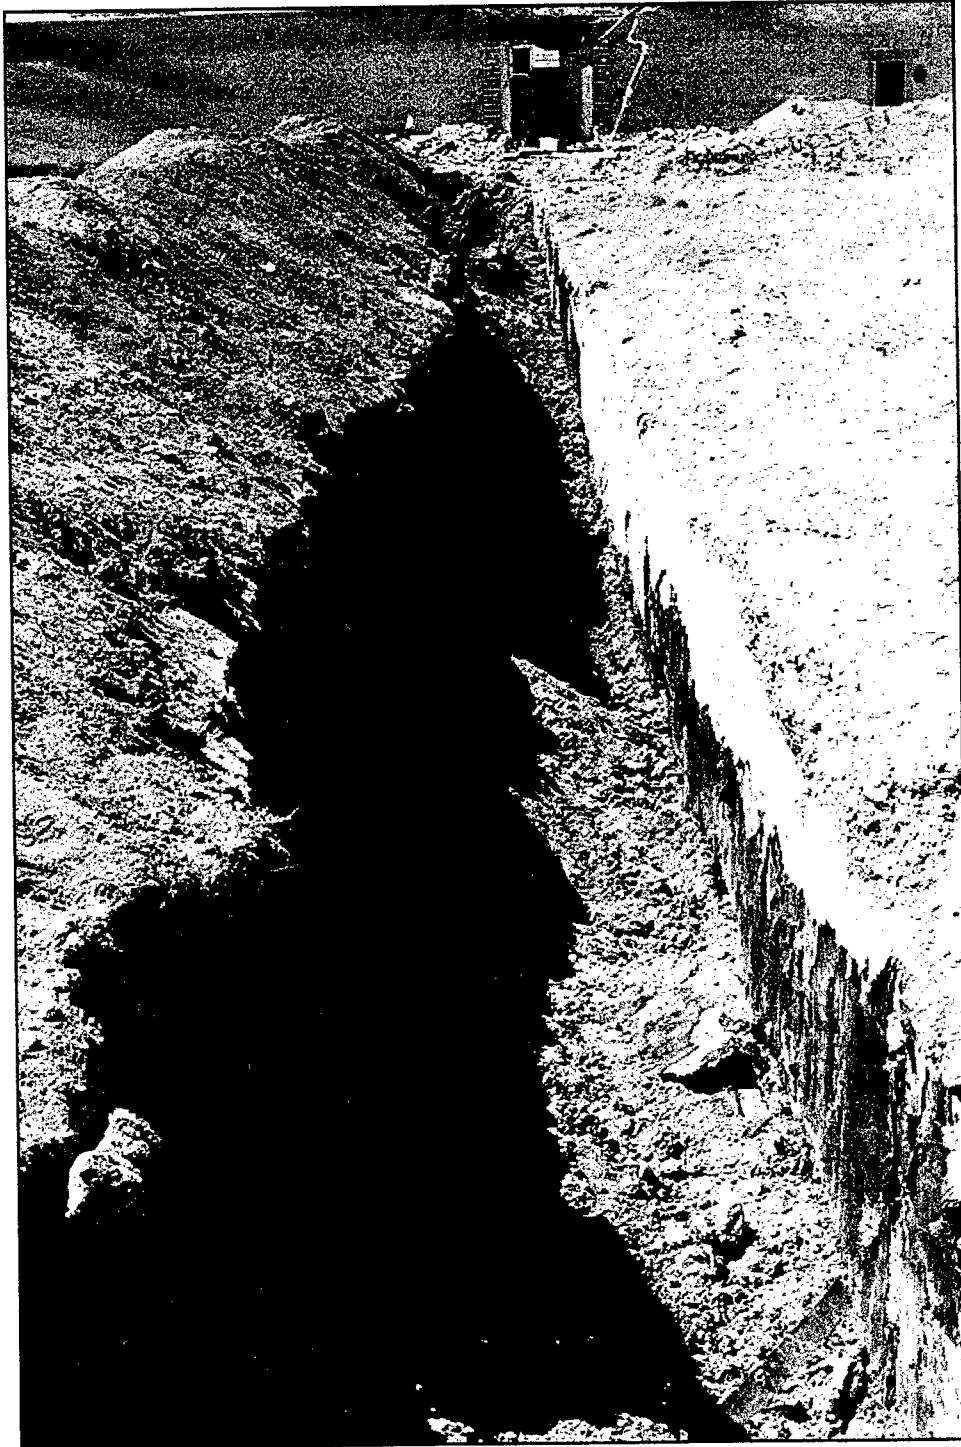
Figure 15. Partially excavated shallow buried tunnel between the cooling system building (in background) and the Launch Control Center (LCC) silo. Derzhavinsk, Regiment 3, Silo 7.

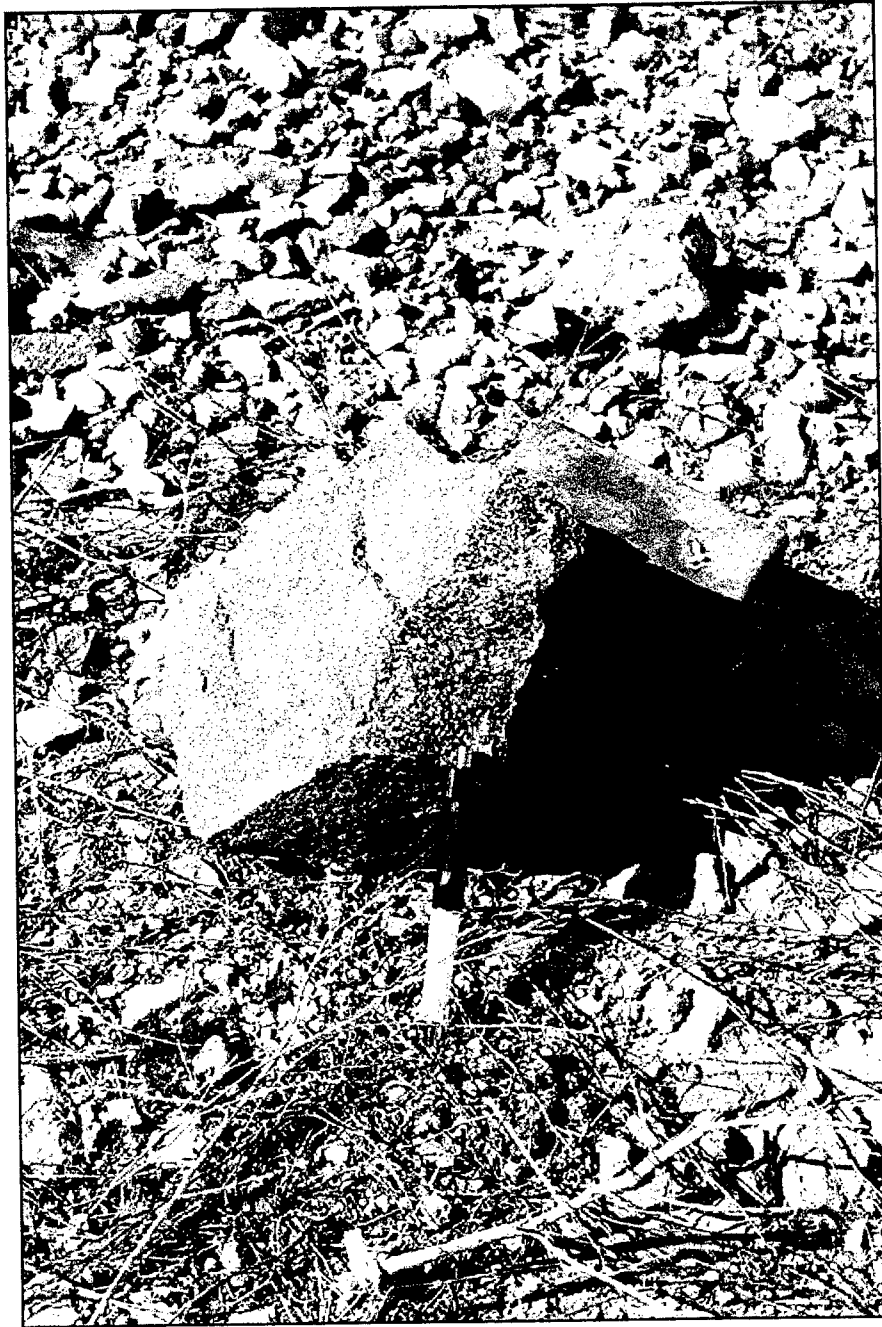
Figure 17. Fragment of a porphyritic igneous rock in the debris field around the crater. The rock has a dark matrix with white veins and crystals. The pen is six inches in length. Derzhavinsk, Regiment 2, Silos 5/7.

The debris that formed the crater rim around the headworks was composed mostly of silt, sand, clay and gravel. At co-located silos 5/7, Regiment 2, several large fragments of igneous and metamorphic rock were observed (Figures 17 and 18). The origin of these rocks is uncertain. The bedrock in the area of the Derzhavinsk base is composed of Paleozoic igneous rocks and Precambrian to Cambrian metamorphic rocks (see the section on Geology). It is possible that the fragments were excavated during the construction of the silo tube and added to the backfill, or the rocks may have been brought in from a quarry two or three kilometers east of the town of Derzhavinsk, and added to the backfill around the headworks. At least some silos appear to have been built up to about 1.5 m above the original ground surface and backfilled, possibly during modification of the original SS-9 silo to accommodate the larger SS-18 missile.

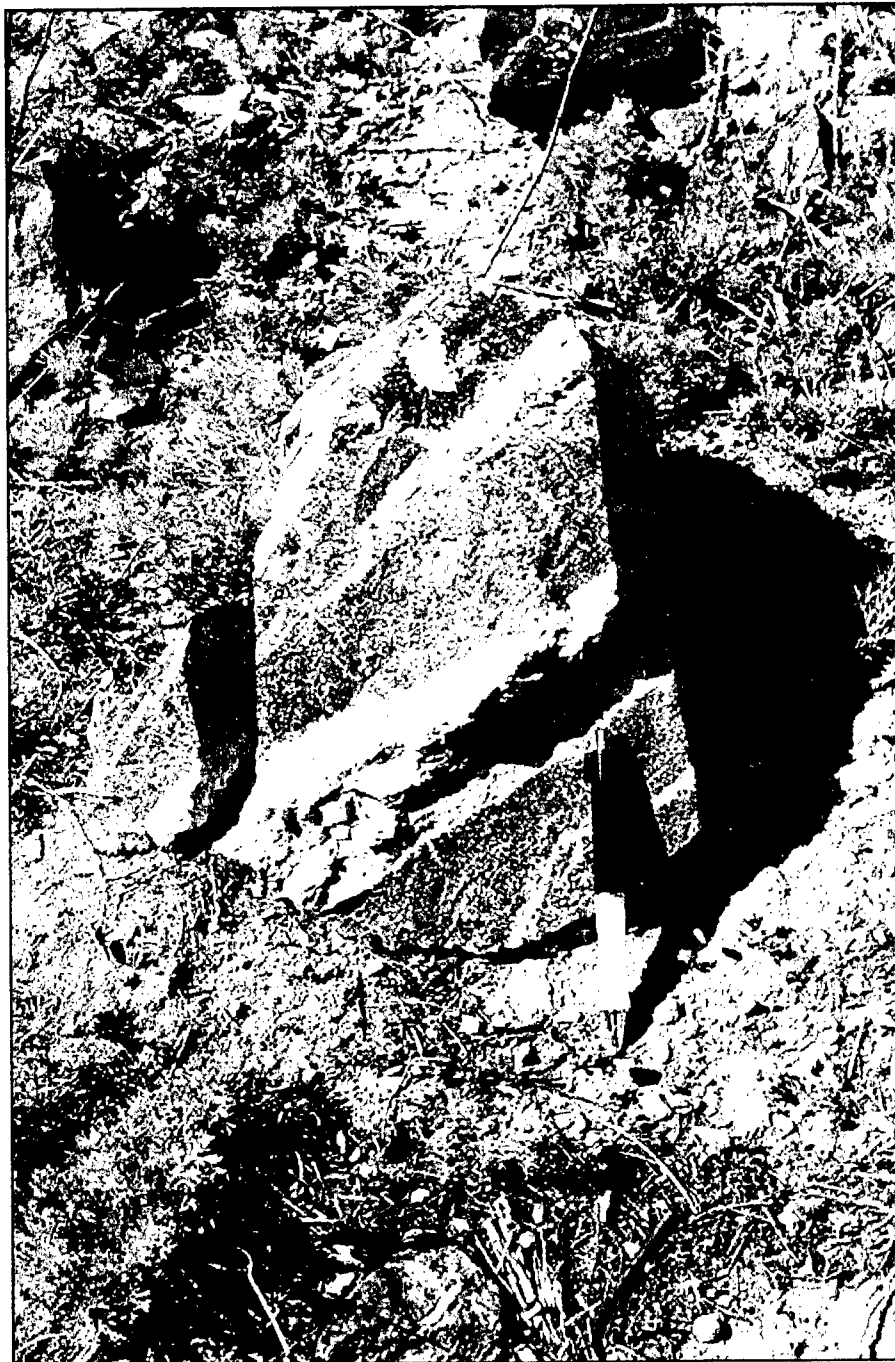
Figure 18. Fragment of banded igneous rock in the debris field around the crater rim. The pinkish bands intruding into the fine-grained matrix give a "gneissic" appearance to the rock. The pen is six inches in length. Derzhavinsk, Regiment 2, Silos 5/7.

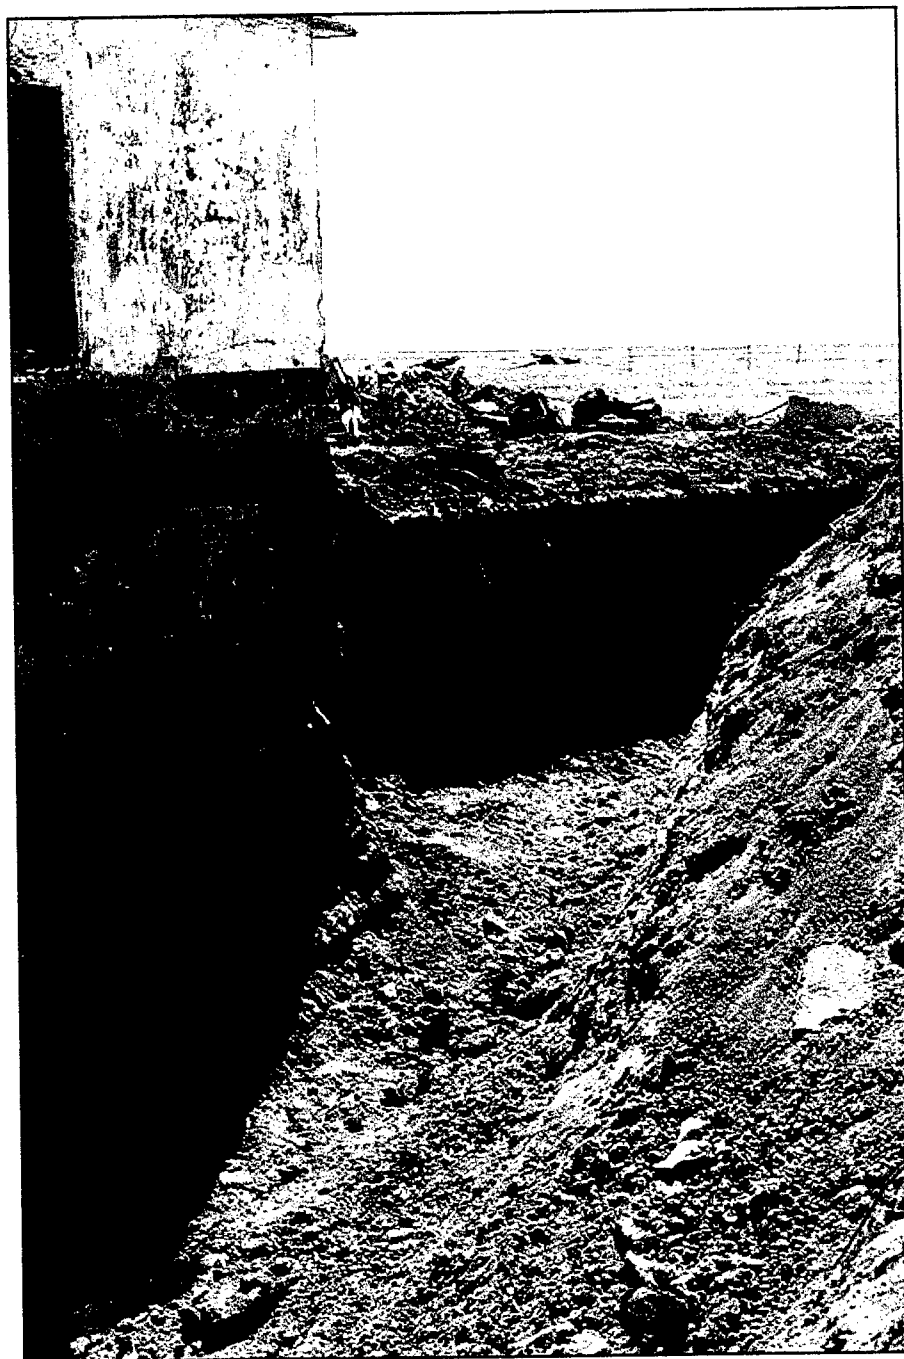
Figure 21. Trenching along side the "Force Protection" security building has exposed the subterranean level of the building and the associated shallow buried tunnel. The buried structures are lined with red clay brick. The excavation is about three meters deep in dry fine-grained silt and clay. Derzhavinsk, Regiment 2, Silo 2.

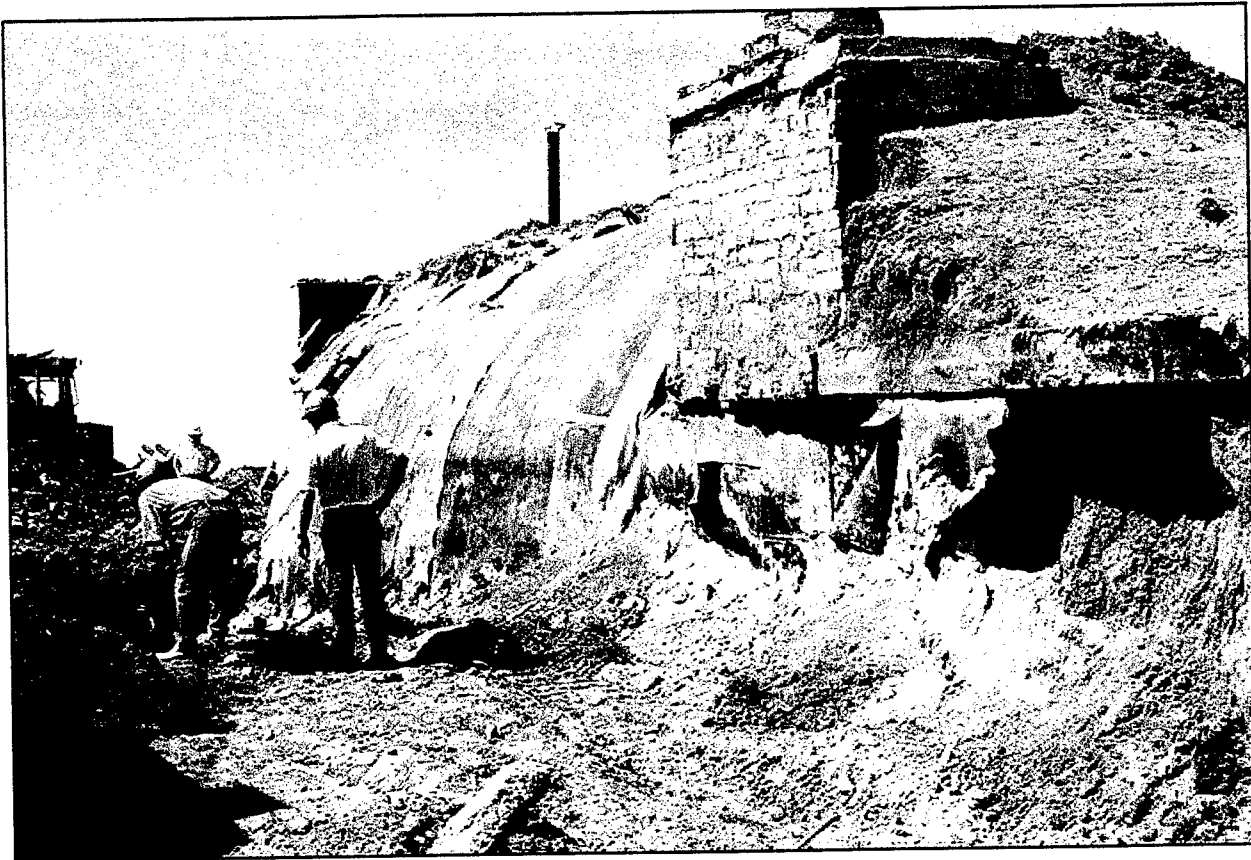
Figure 33. Bermed storage facility being exhumed for destruction and disposal. A black tar paper-like material covers the reinforced concrete. Derzhavinsk, Regiment 2, Silo 3.

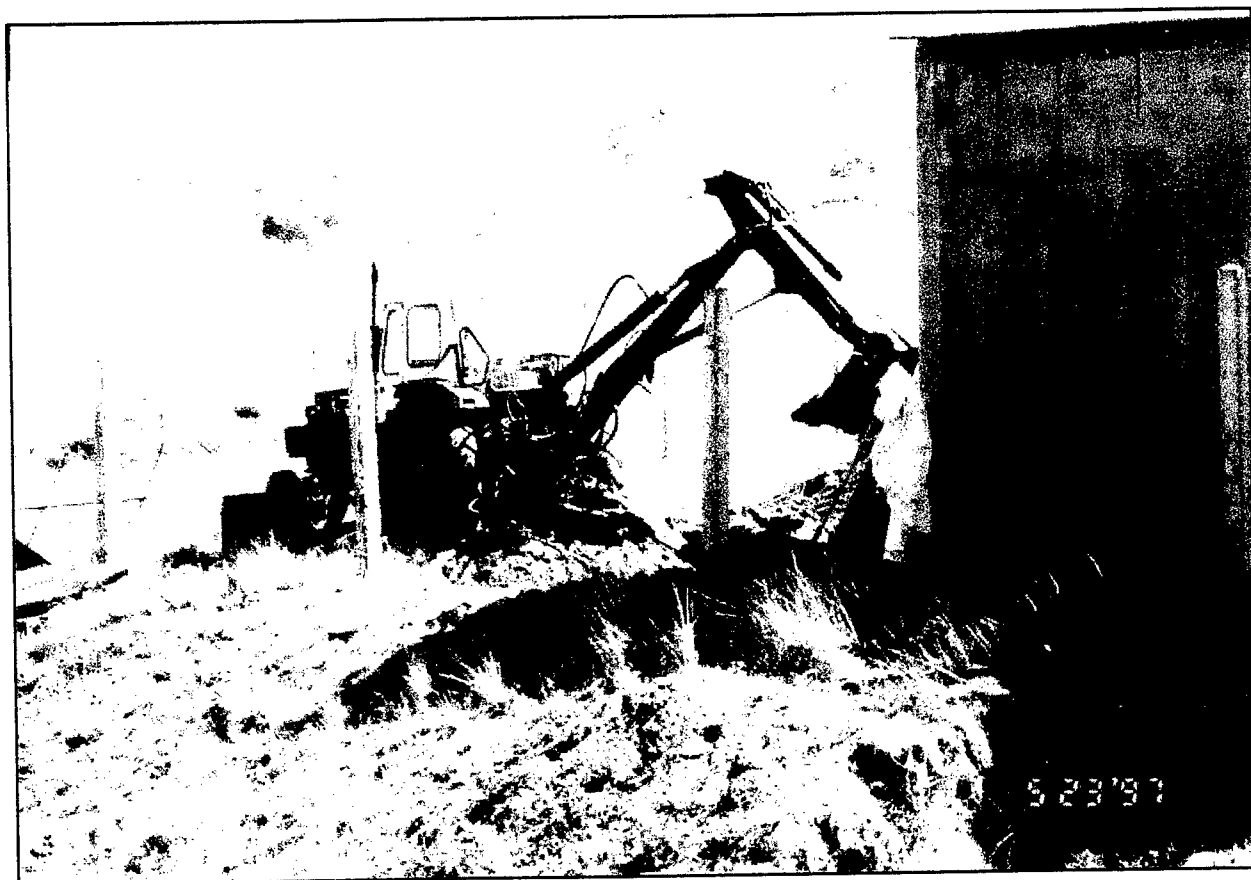
Figure 35. Abatement contractor crew removing PCB contaminated soil near a transformer building. Zhangiz Tobe. Photo courtesy of Brown & Root/ABB SUSA.

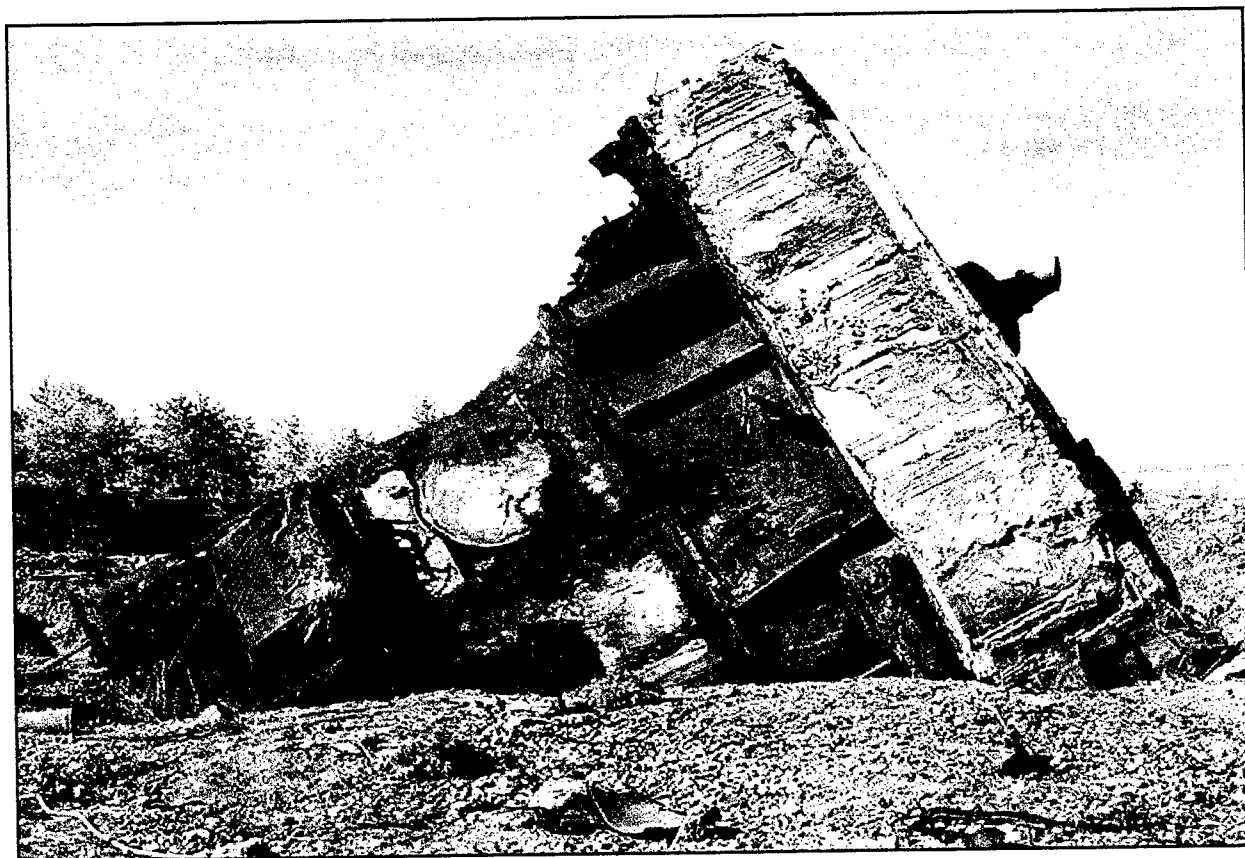
Figure 37. Relatively intact LCC silo door pocket still attached to part of the headworks wall.  
Derzhavinsk, Regiment 2, Silo 7.

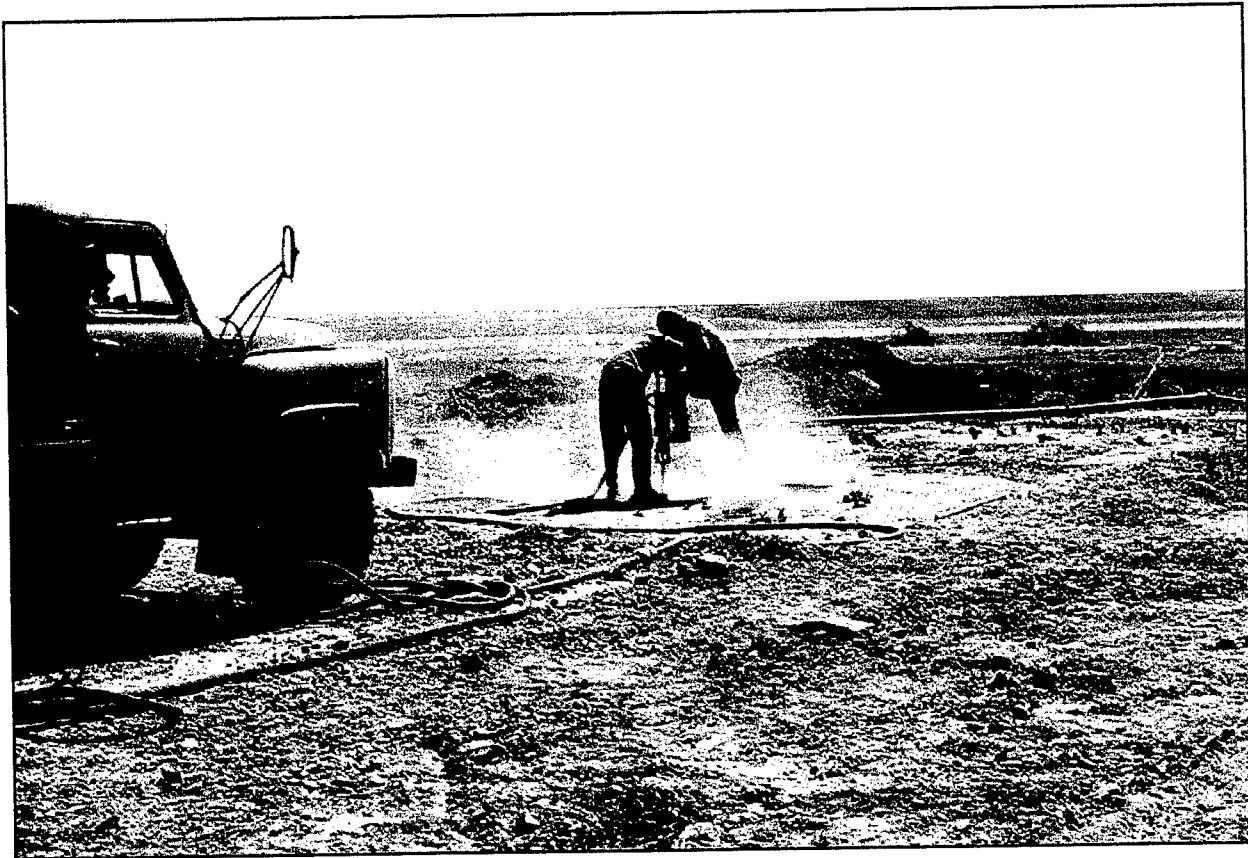
Figure 39. Drilling dynamite emplacement holes in the two-meter thick reinforced concrete support blocks of the transporter loading ramp. Derzhavinsk, Regiment 2, Silo 2.

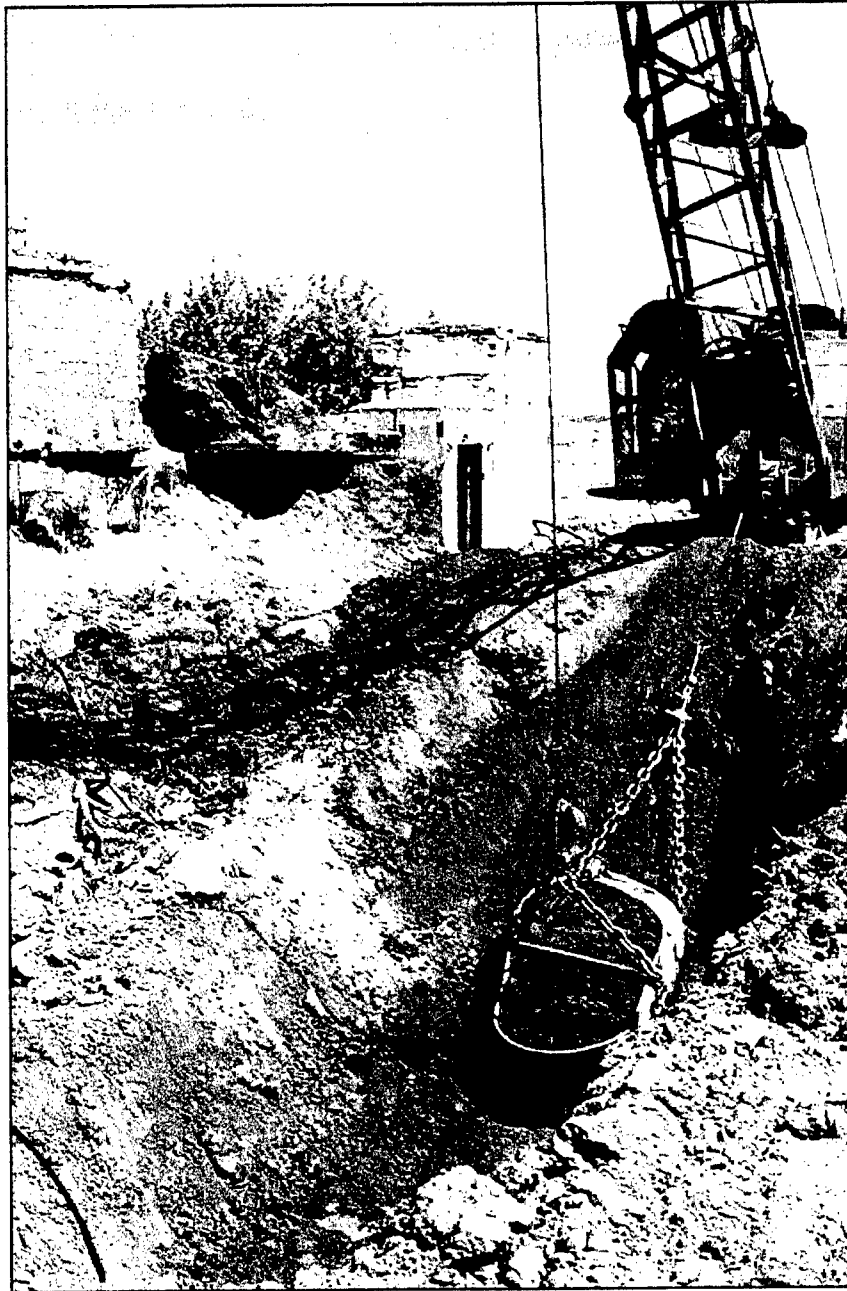
Figure 46. Excavating a pit along side a bermed storage bunker for the disposal of the bunker. The earth is brown, fine-grained silt and clay; the gray-white material is poorly sorted sand, possibly dumped in place during construction. Derzhavinsk, Regiment 2, Silo 3.
